AQUATIC LEASE INSPECTION REPORT

LEASE NUMBER: 22-A02332 START:11/1/2004 END:10/31/2034

USE: COMMERCIAL MARINA LEGAL: Sect 11; TWN 24-N; RNG 1-E

LESSEE NAME: SEVEN Js INVESTMENT LIMITED PARTNERSHIP

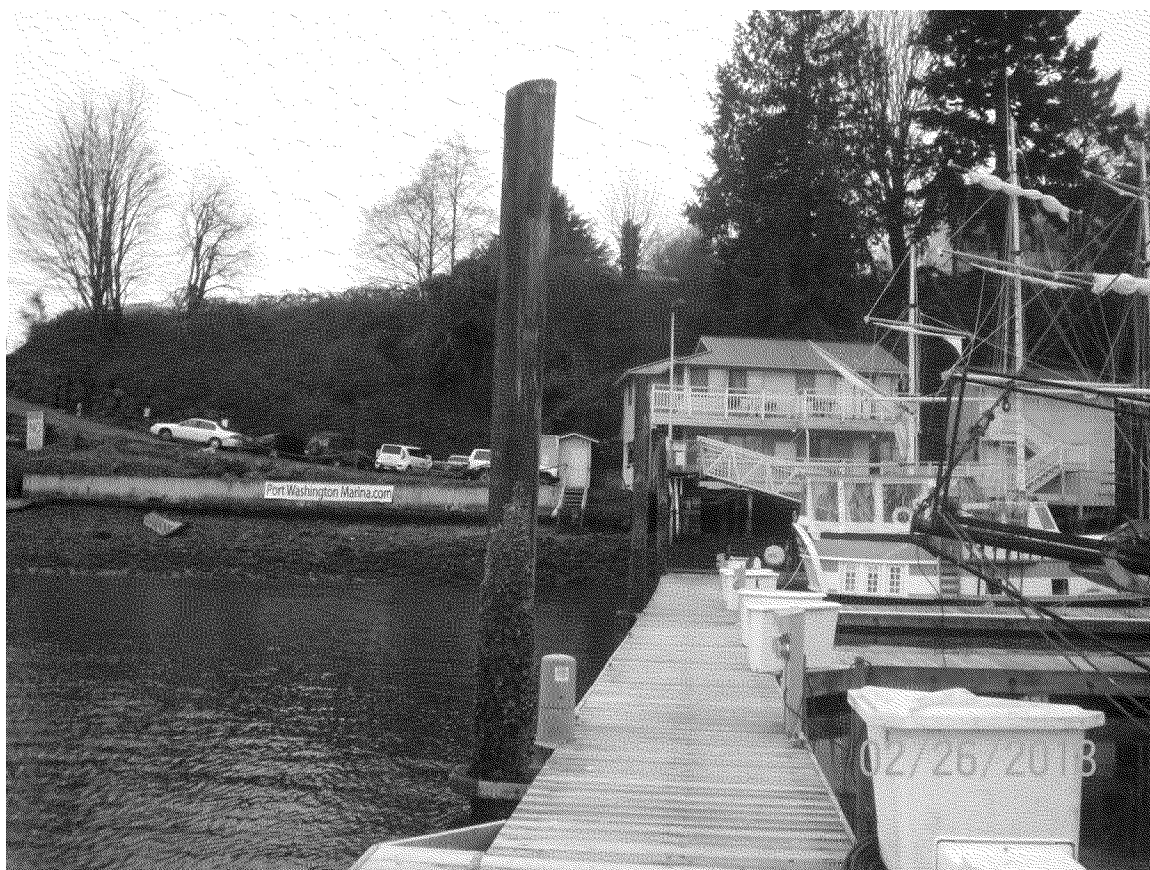
Figure 1: Photo showing the concrete bulkhead, parking area, and two NWD buildings in the background. E-Dock in the foreground

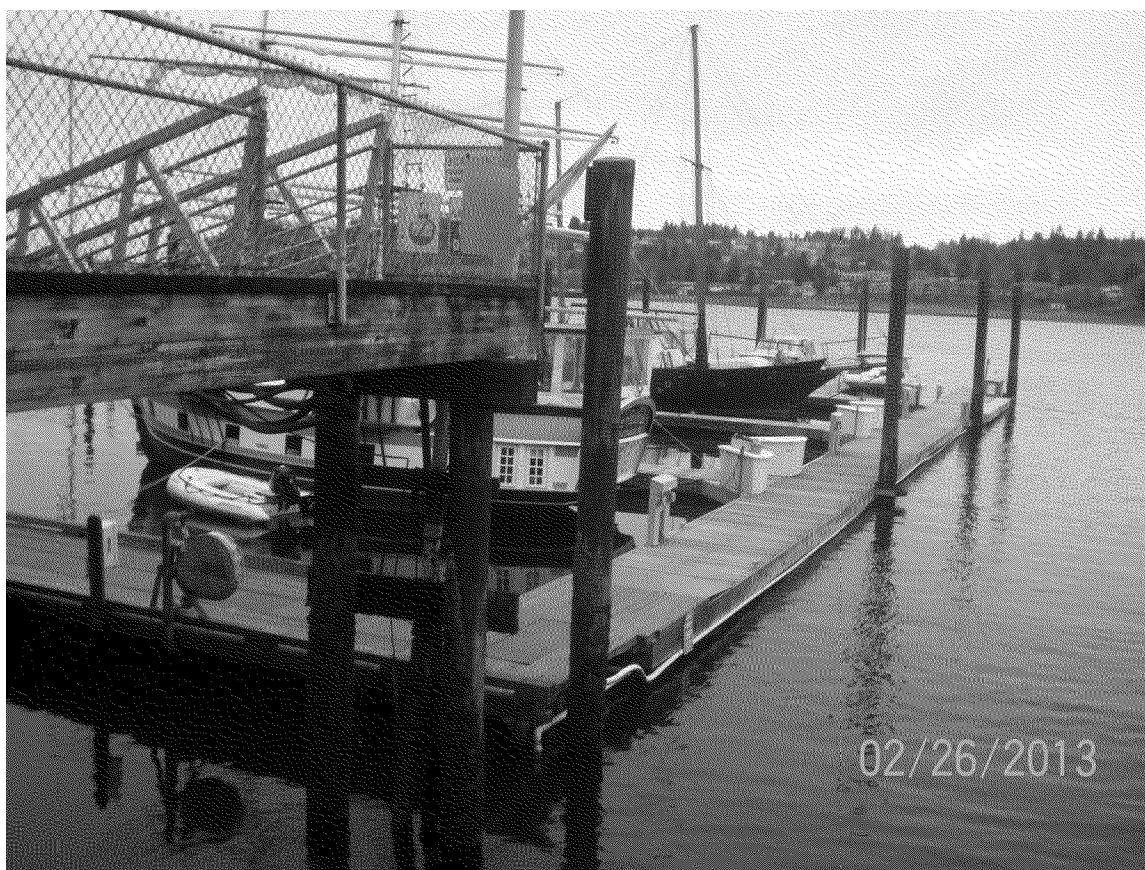
Figure 4: Photo showing Dock-E. The pump-out is located at the end of Dock-E

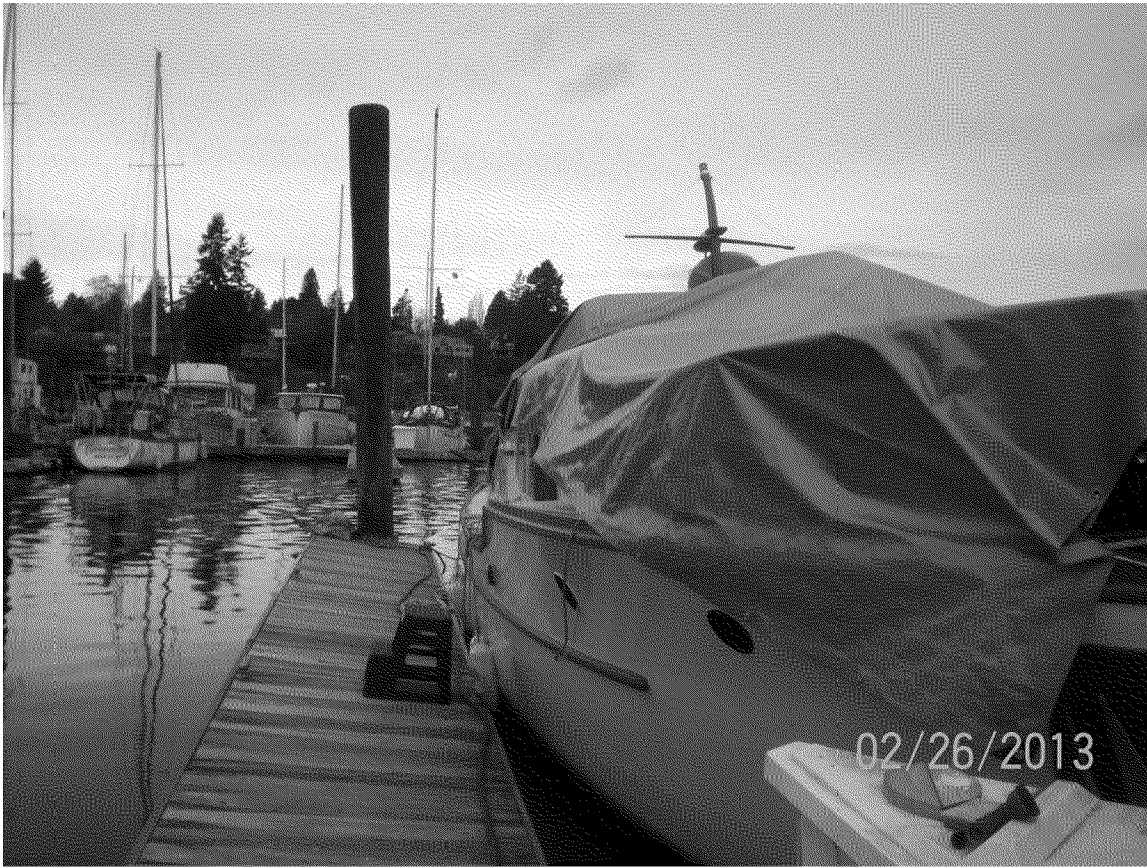
While at the marina many of the floats were observed to be listing. **Recommendation** – the floats be maintained so they are level and no exposed foam remains.

Figure 6: Photo showing the moorage at the end of Dock-D. The dock can be seen listing towards the vessel. Several other finger-piers have pronounced list.

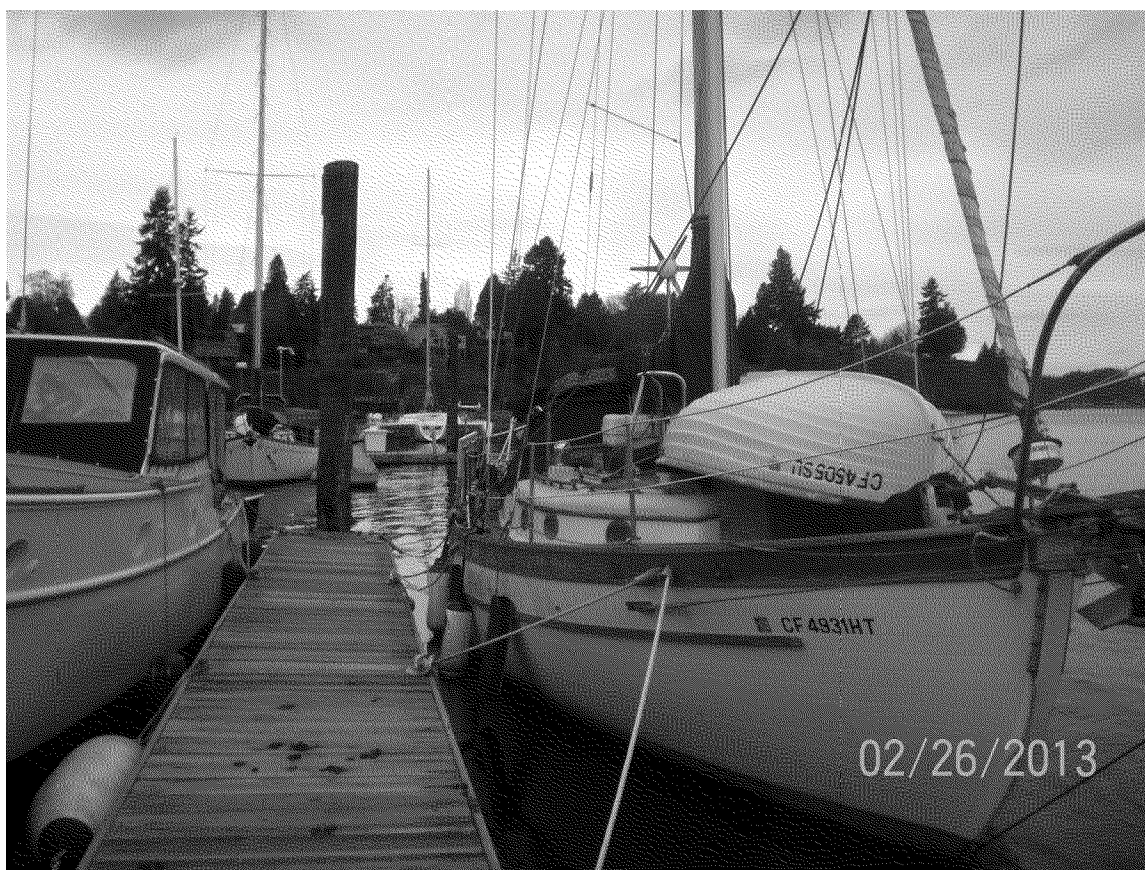
Outer Harbor Line: State Constitution and law do not allow DNR to rent the area outside the outer harbor line to private entities. Some of the marina improvements are shown extending beyond the outer harbor line. The marina is currently mooring vessels outside the outer harbor line. – **Recommendation:** have the marina move tenants inside the outer harbor line. Have the tenant remove the anchor cleats to prevent moorage outside the outer harbor line. Modify the lease, or maybe send a letter, to specify that the improvements need to be removed from the area outside the outer harbor line in conjunction with marina replacement/repairs. Potentially, charge a U&O for the area extending beyond the outer harbor line at the WD rent rate.

Figure 7: Photo showing moorage at the end of Dock-B (foreground) and Dock-A (background). These vessels are clearly moored beyond the outer harbor line.

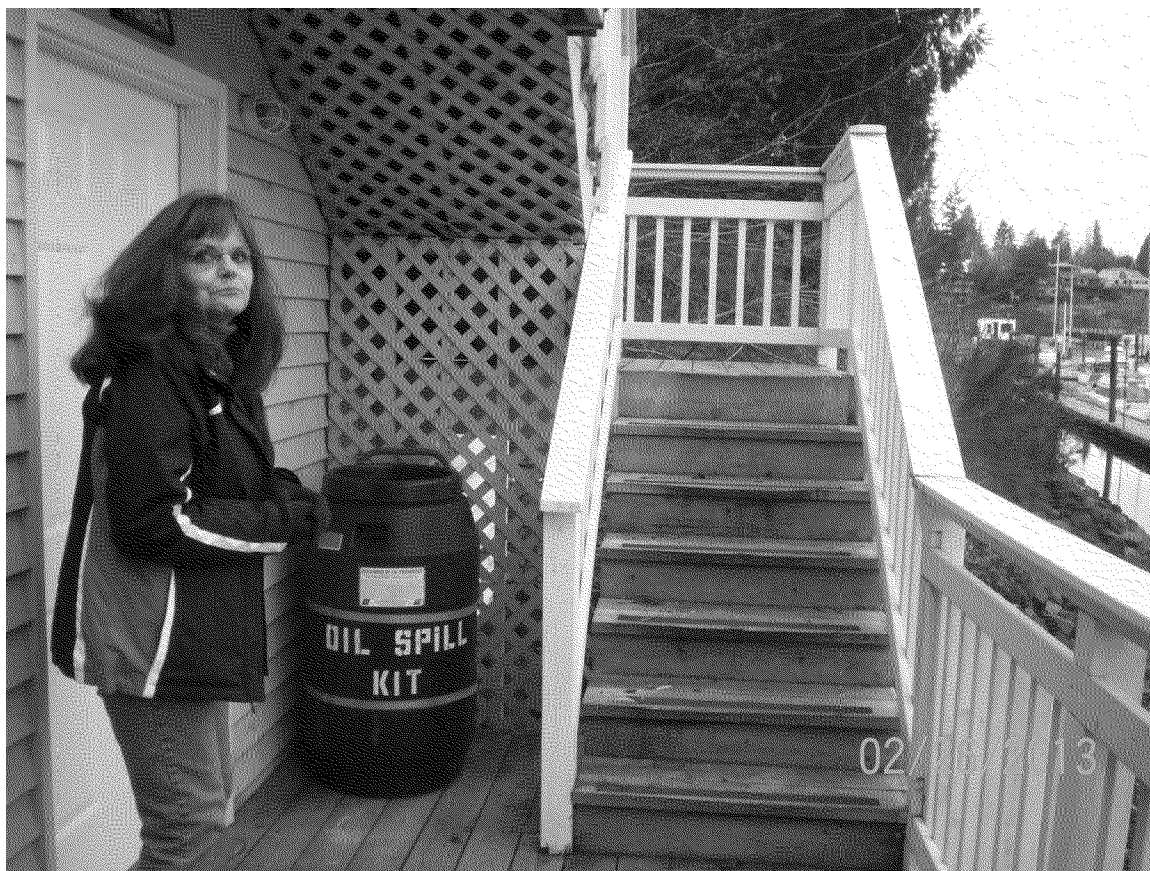
Figure 9: Photo showing the oil spill kit which is located on the pier near the restroom building.
